| This ASB revises ASB-912-061 dated 26 May 2012

ALERT SERVICE BULLETIN

Replacement of the pressure side fuel hose at fuel pump part no. 893114 for ROTAX® Engine Type 912 (Series)

ATA System: 73-00-00 Fuel system

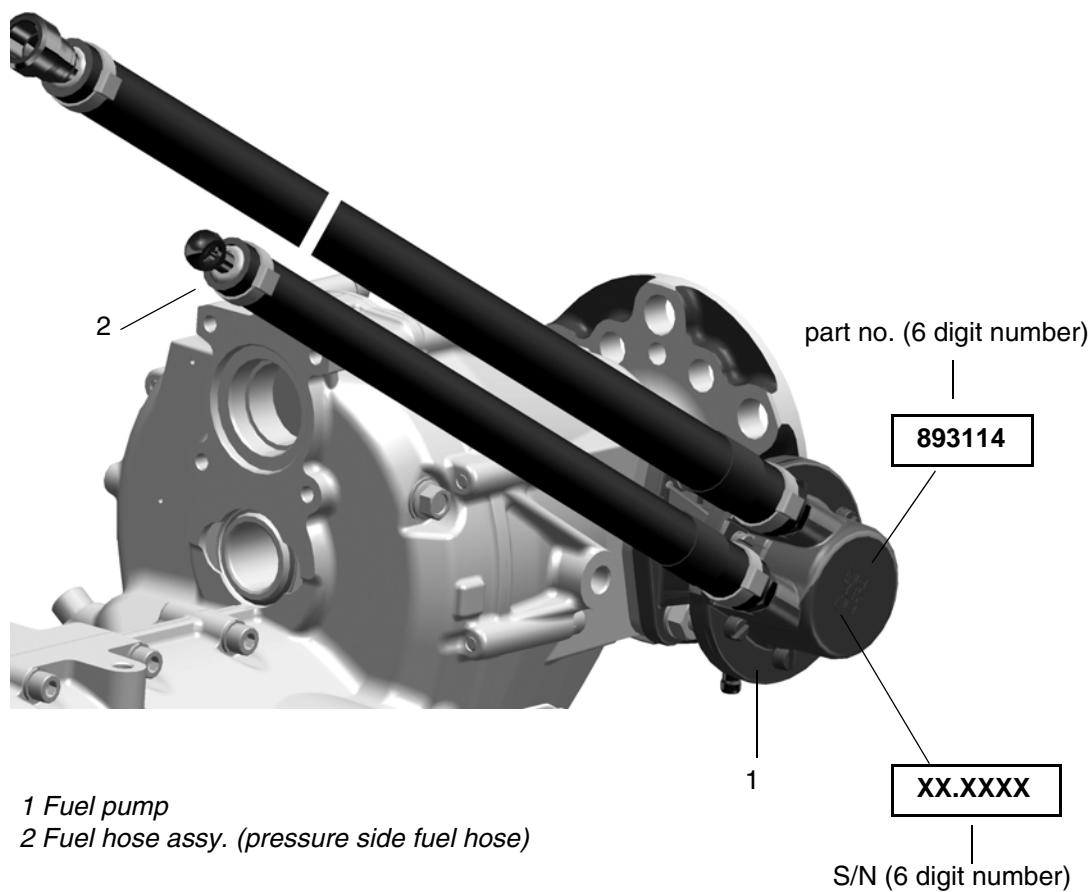
Fig. 1
Fuel pump

if they are equipped with the genuine ROTAX® fuel pump part no. 893114.
See [Fig. 1](#)

Due to variations in the manufacturing of the fuel hose, rubber particles may become detached. These particles can interfere or suppress the fuel mixture in the carburetor. This disturbance in the fuel mixture may lead to rough engine operation, engine misfire and can cause an engine shut down.

Replacement of the pressure side fuel hose at fuel pump part number 893114 for ROTAX® engine type 912 (Series).

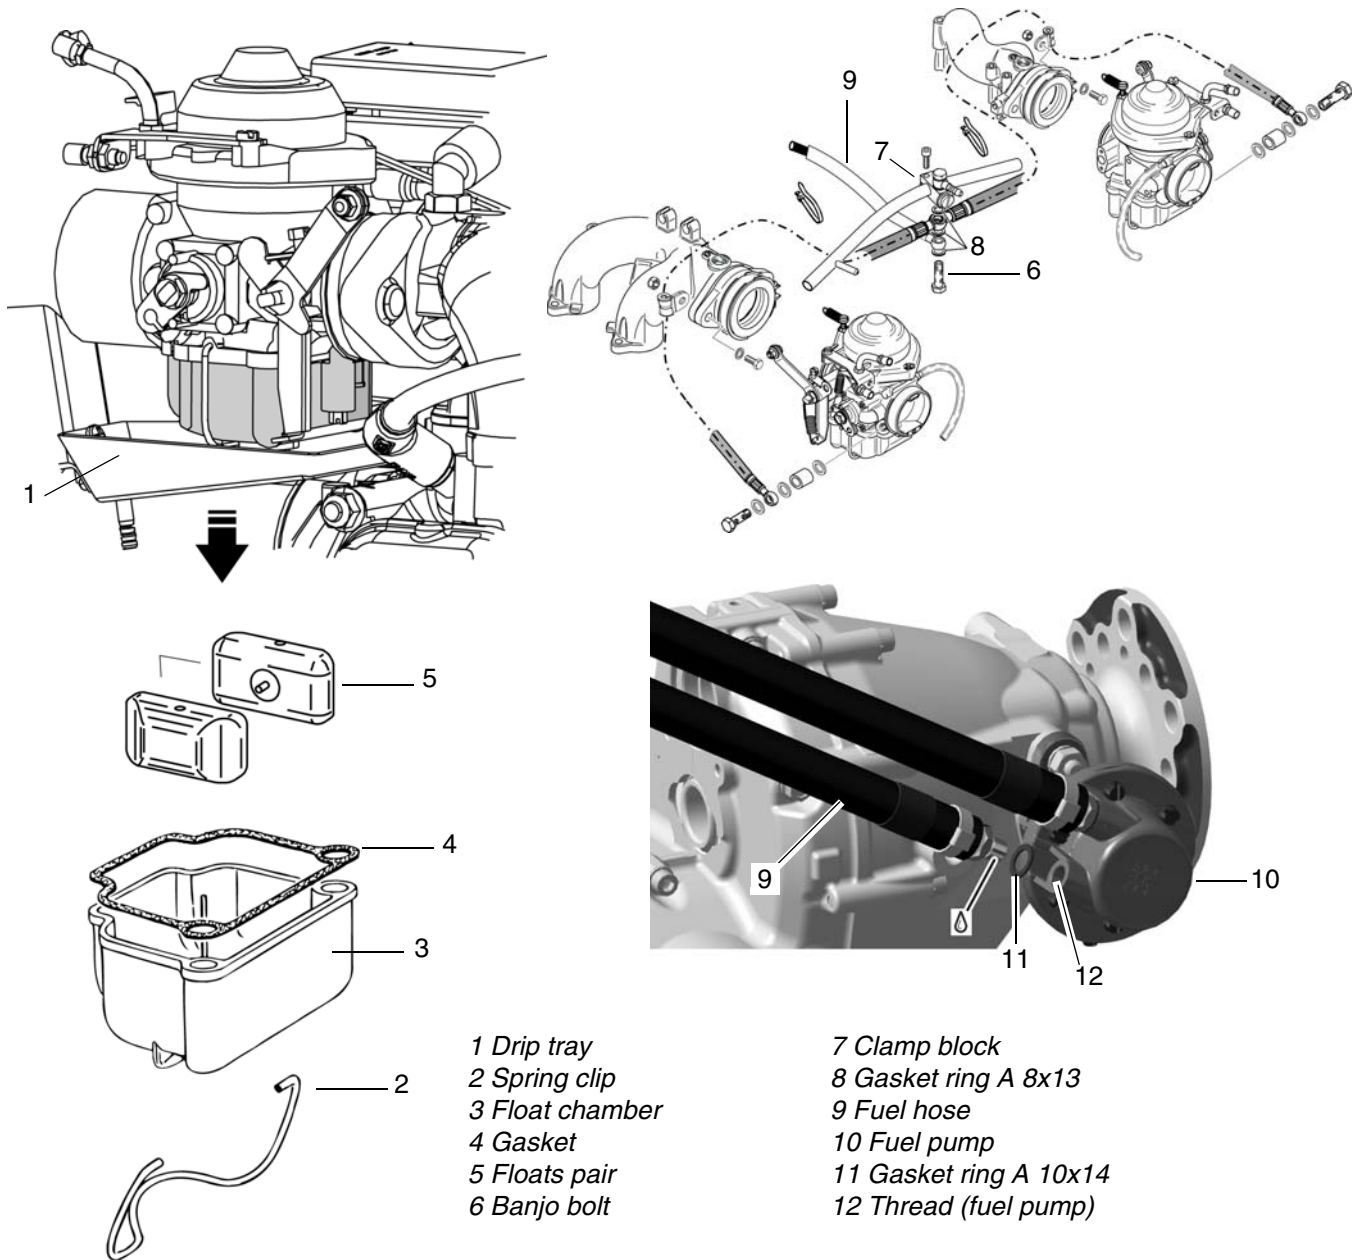
Fig. 2
Carburetor, Fuel pump

Several carburetors have been found with contamination (dirt, remains of rubber from fuel lines etc.) in the float chamber.

This contamination could possibly cause a partial or complete blockage of the idle or main jet or of other ducts vital for operation, leading to poor performance or stoppage of engine.

In case of contaminations of the float chambers first the cause must be found and the relevant measures need to be taken. Possibly the whole fuel system including carburetors needs to be cleaned and checked.

Step	Procedure
1	Remove drip tray (1) - if equipped.
2	Perform visual check on carburetors and its actuation.
3	Open spring clip (2).
4	Remove float chamber (3) including gasket (4) and both floats (5).
5	Check float chamber for contamination.

Step	Procedure
1	Remove banjo bolt (6) from clamp block (7) together with 3 gasket rings (8).
2	Remove the fuel hose (9).
3	Remove the fuel hose (9) from the fuel pump (10) together with gasket ring (11).

Step	Procedure
1	Inspection of the thread (12) from the fuel pump and remove possible sealing materials.
2	Clean and degrease thread (12) of the fuel pump.

Step	Procedure
1	Install the new fuel hose (9) and new gasket ring A 10x14 (11) with LOCTITE 243 on the fuel pump. Tightening torque 10 Nm (90 in.lb).
2	Install fuel hose (9) and the banjo bolt (6) with new gasket ring (8) on the clamp block (7). Tightening torque of banjo bolt (6) 10 Nm (90 in.lb). Check that the fuel hose is not under strain or tension.
